**DTV Channel 6 Interference to FM Band Reception**

**Laboratory Test Report**

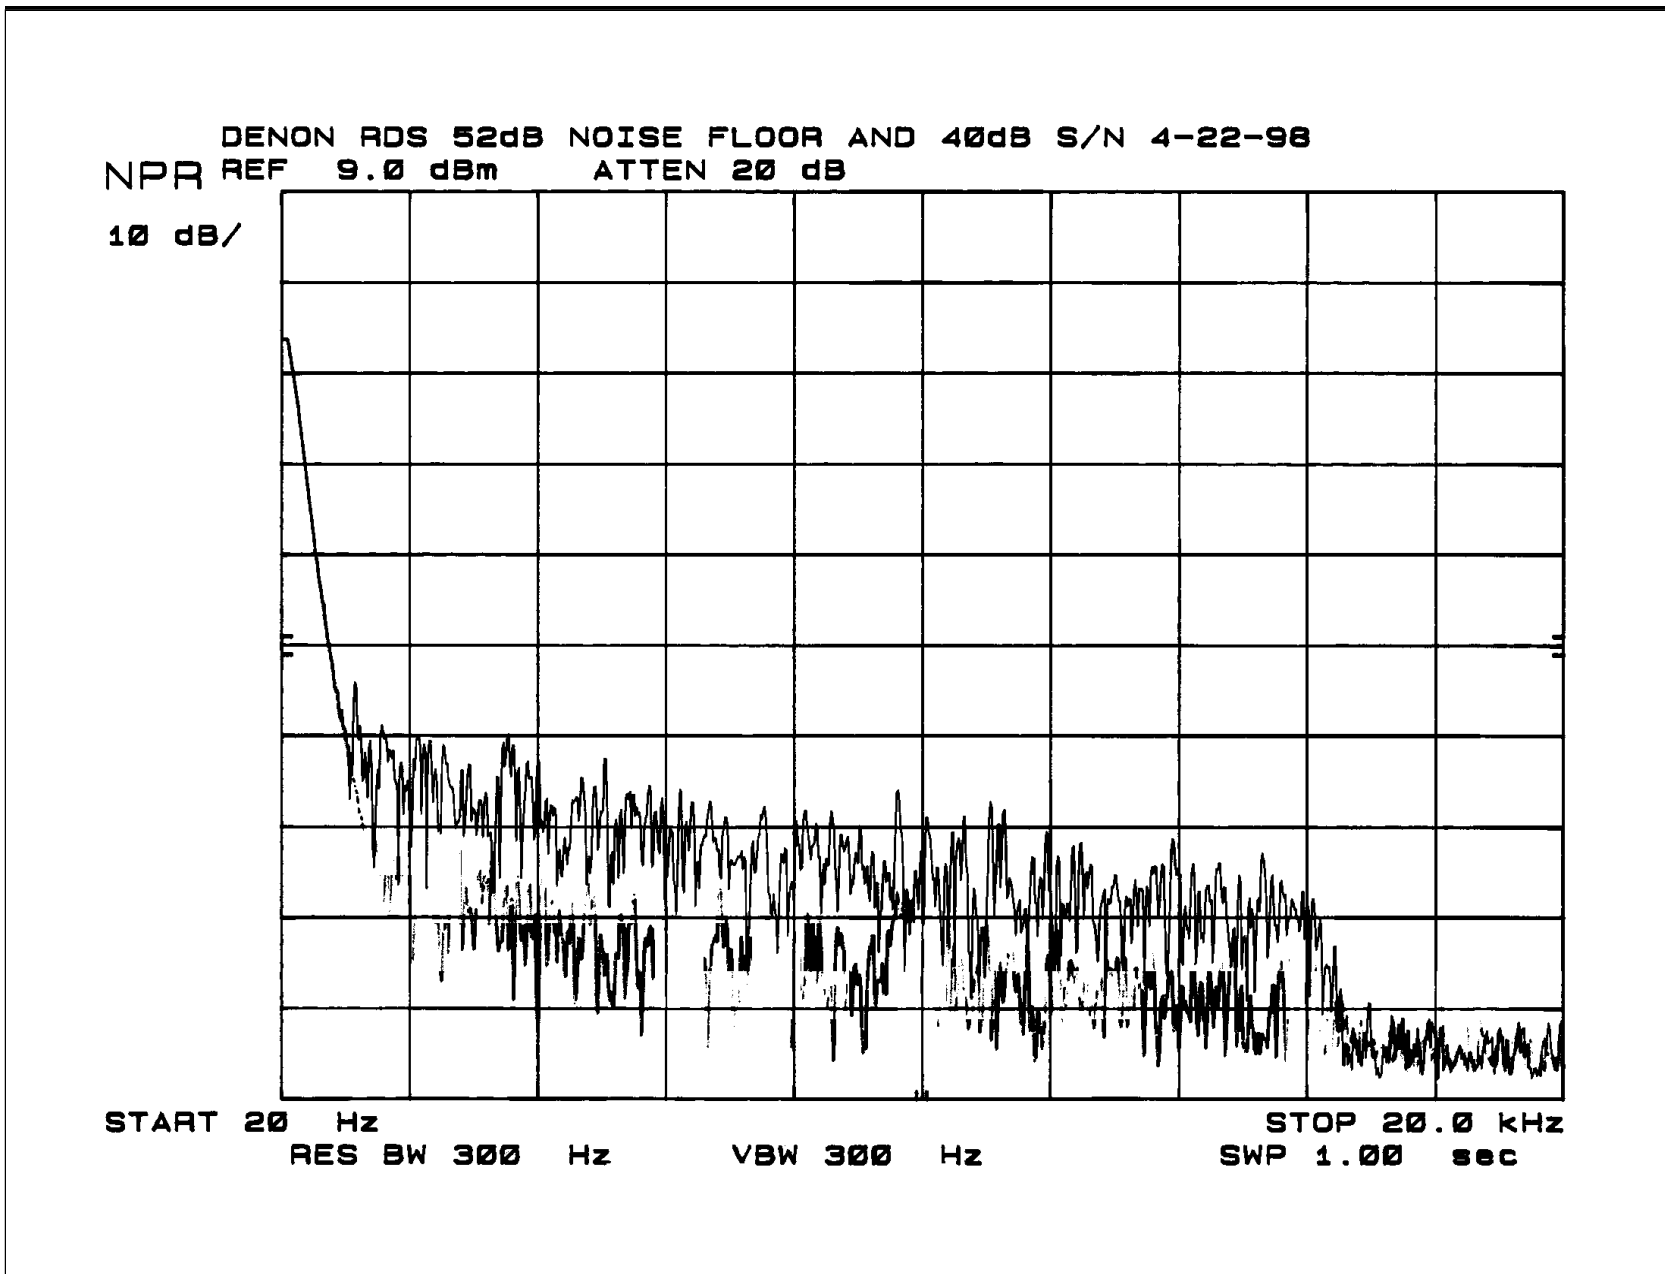
**Denon TU-380 RD Noise Floor Plot**
