DTV Channel 6 Interference to FM Band Reception

Laboratory Test Report

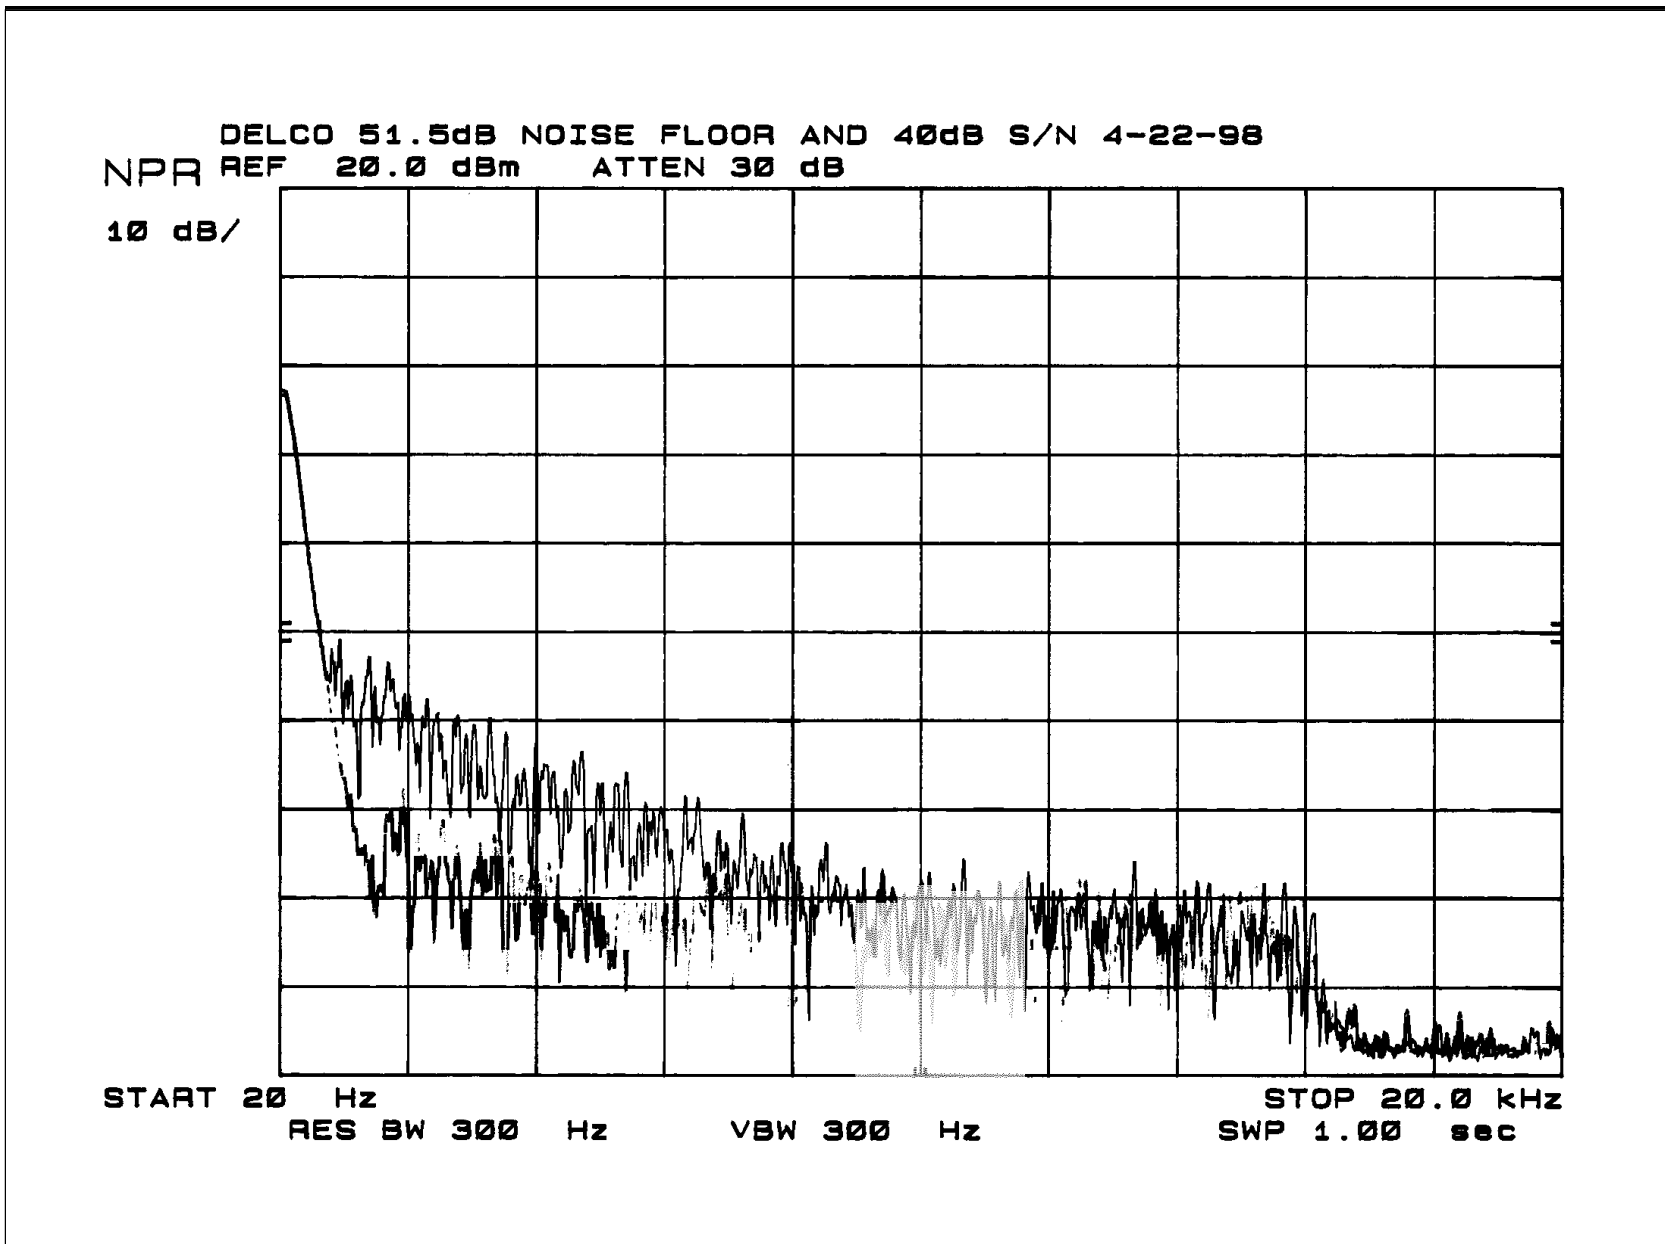
Delco Noise Floor Plot
